**Tier 1 Report of
Facility Condition Assessment**

**For
City of Los Altos
Hal Brady Hall
97 Hillview Avenue
Los Altos,
94022-3740**

Date of Report: June 10, 2016

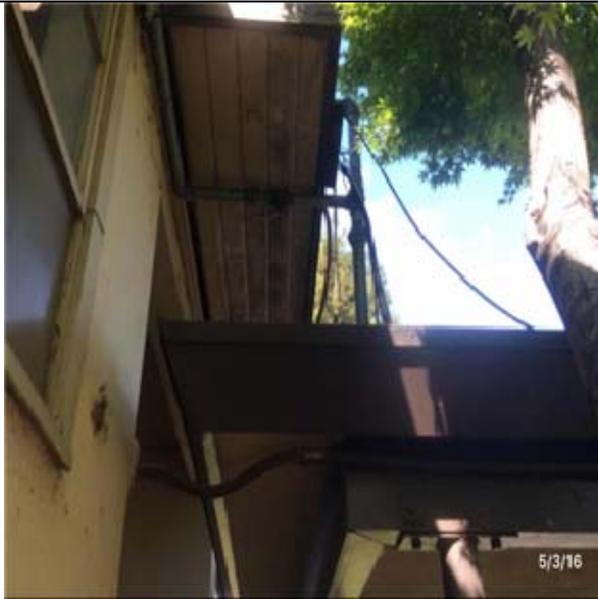
B1023 Canopies:- View of Canopies - Wood Joists Supporting Exterior Grade Plywood

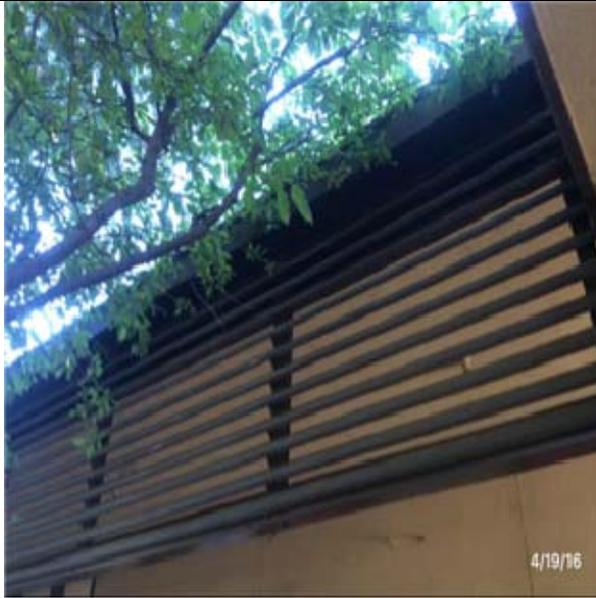
B2014 Exterior Sun Control Devices:- View of Exterior Sun Control Devices

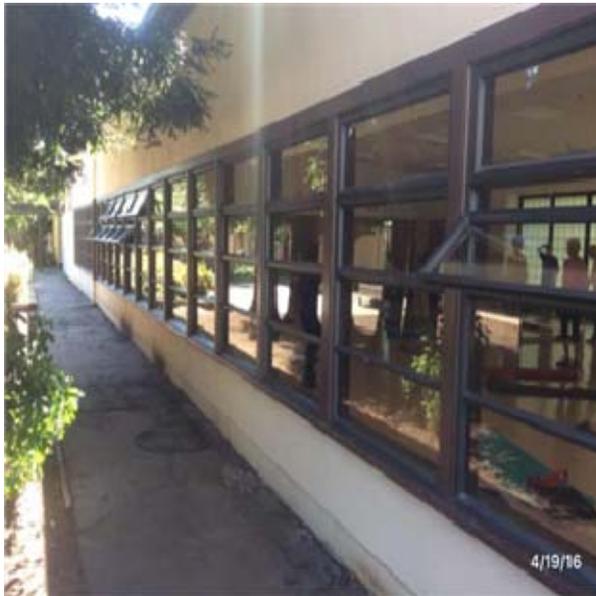
B2021 Windows:- View of Aluminum Window Units - Fixed or Single Hung

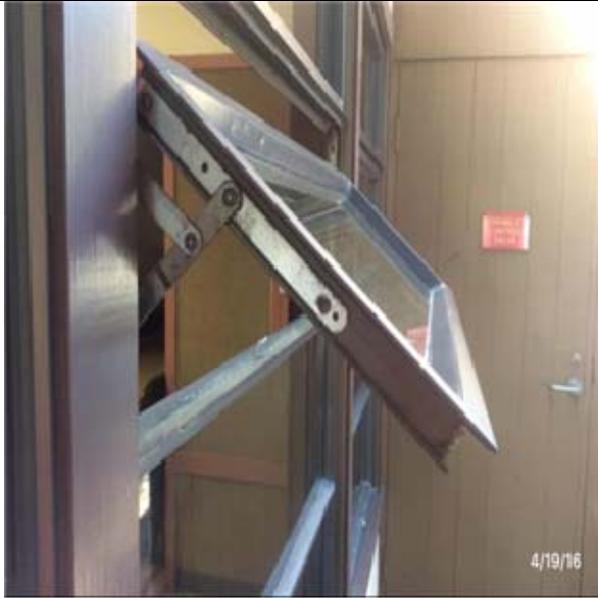
B2021 Windows:- View of Aluminum Window Units - Fixed or Single Hung

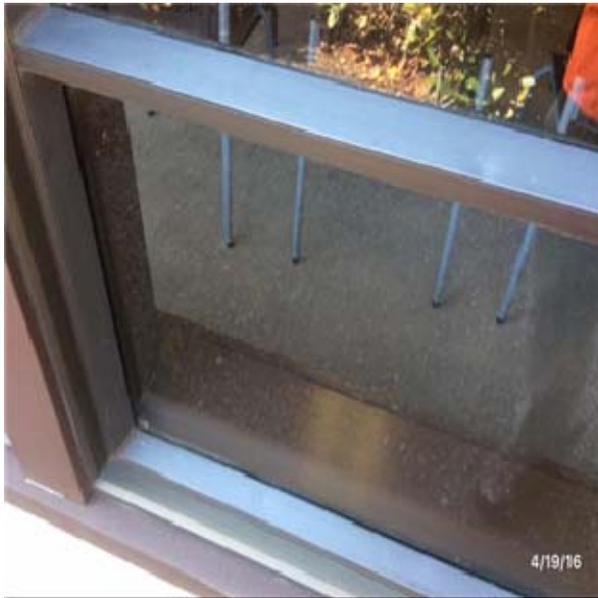
B2021 Windows:- View of Aluminum Window Units - Fixed or Single Hung

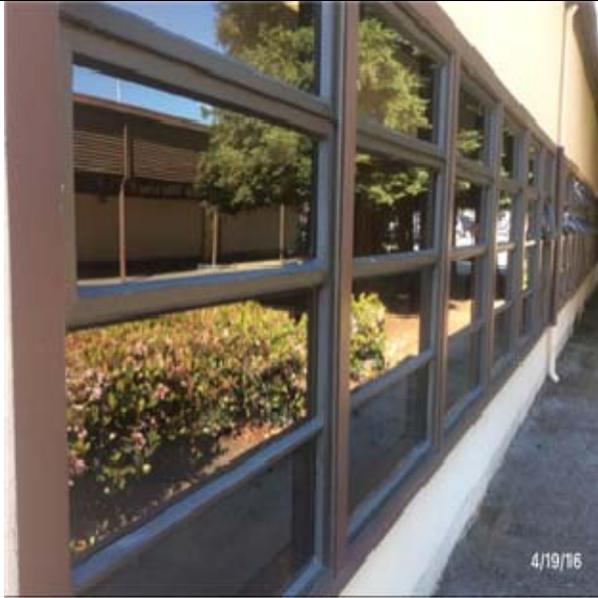
B2021 Windows:- View of Aluminum Window Units - Fixed or Single Hung

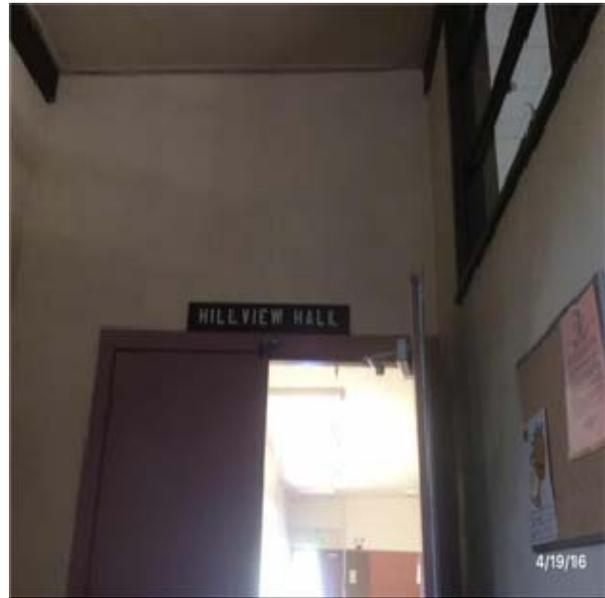
B2032 Solid Exterior Doors:- View of Double Solid Core Wood Doors

- + B Shell: Replace Double Solid Core Wood Doors at an estimated cost of \$7,822 in year 2021
- + C Interiors: Replace Operable Walls, ie hotel ballroom type at an estimated cost of \$17,744 in year 2016

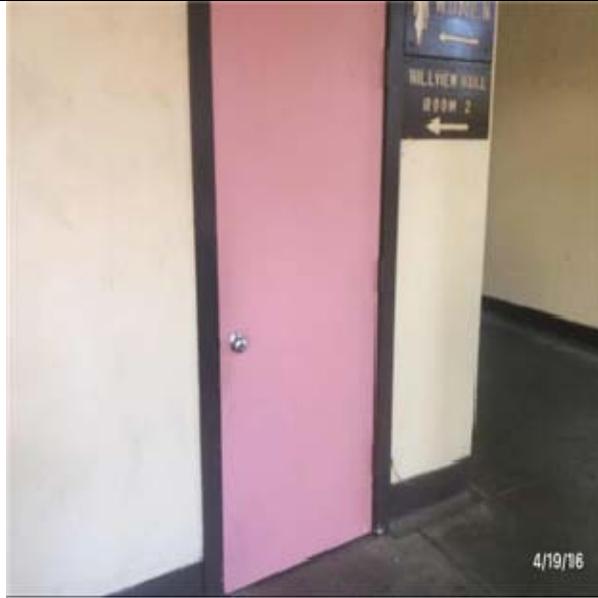
B2032 Solid Exterior Doors:- View of Single Solid Core Wood Doors

- + B Shell: Replace Single Solid Core Wood Doors at an estimated cost of \$10,973 in year 2016
- + B Shell: Repair and repainted at an estimated cost of \$11,690 in year 2016

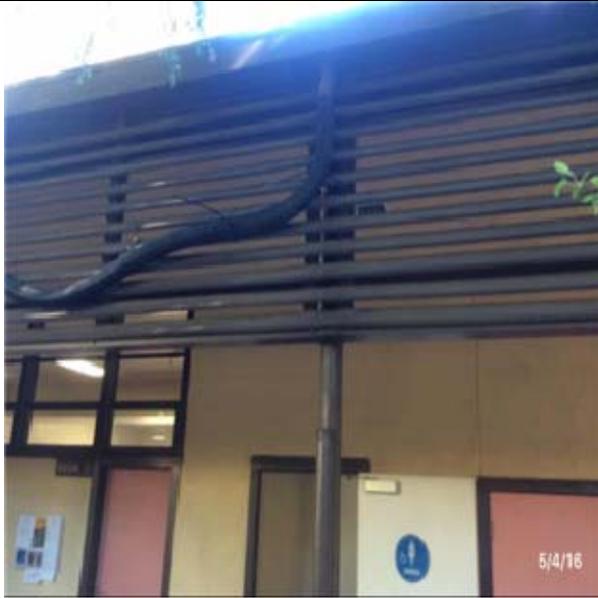
B3016 Gutters and Downspouts:- View of Galvanized Steel Perimeter Gutters & Downspout

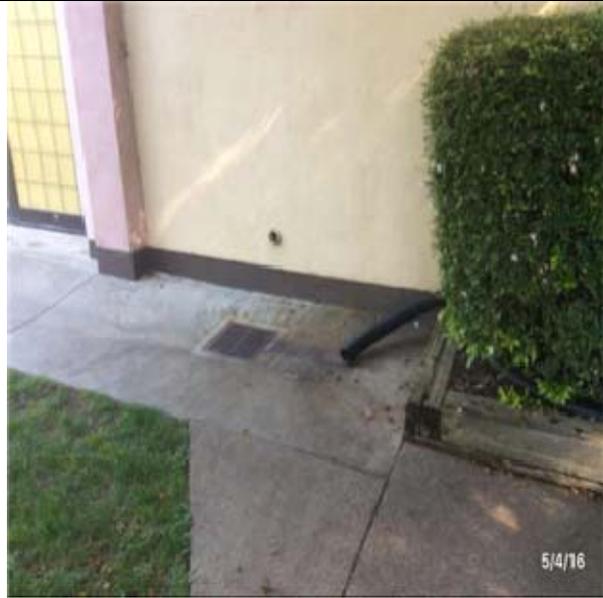
B3016 Gutters and Downspouts:- View of Galvanized Steel Perimeter Gutters & Downspout

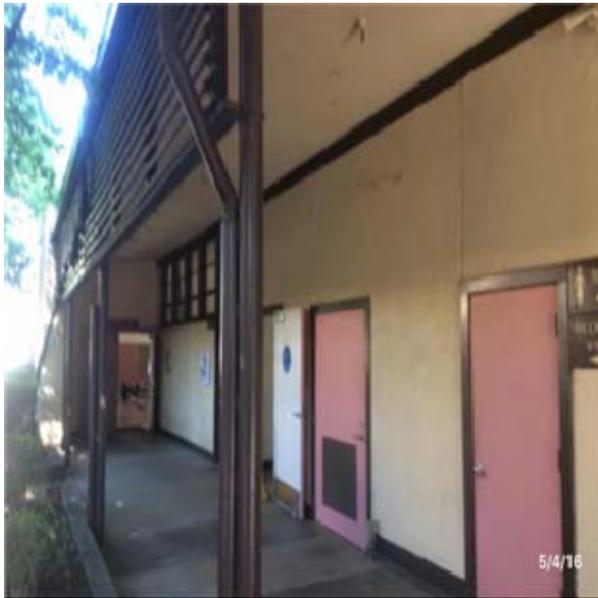
B3016 Gutters and Downspouts:- View of Galvanized Steel Perimeter Gutters & Downspout

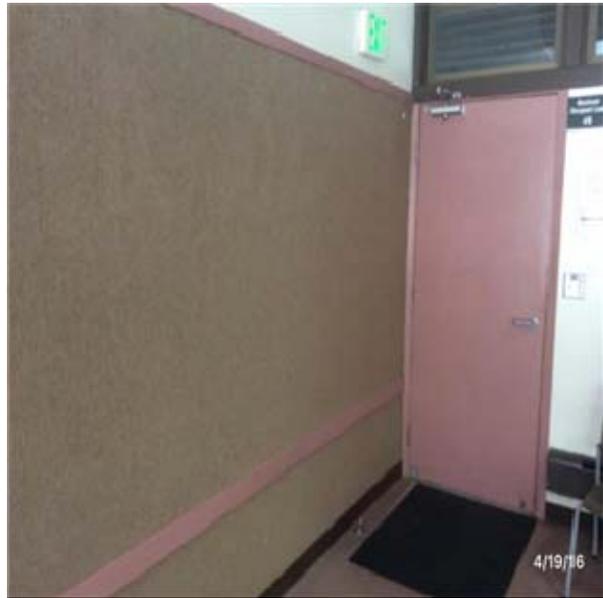
C1011 Fixed Partitions:- View of Stud walls with Board Finish

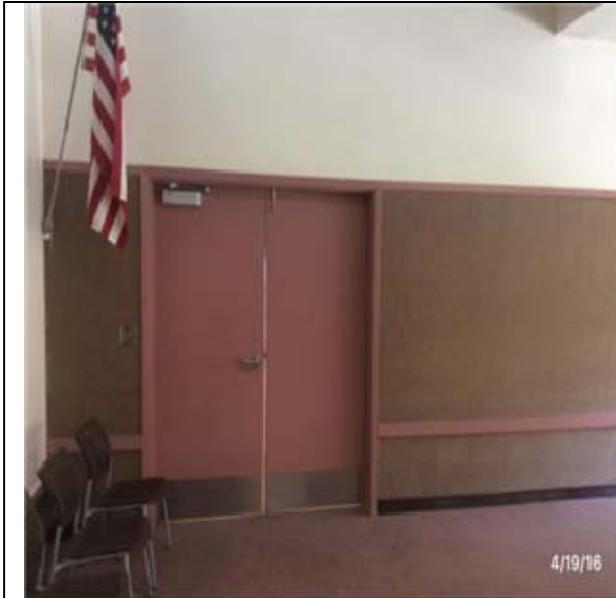
C1011 Fixed Partitions:- View of Stud walls with Board Finish

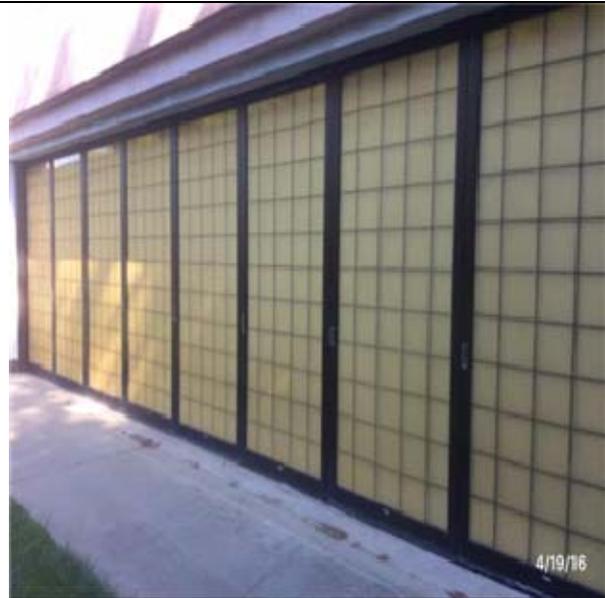
C1013 Retractable Partitions:- View of Operable Walls, ie hotel ballroom type

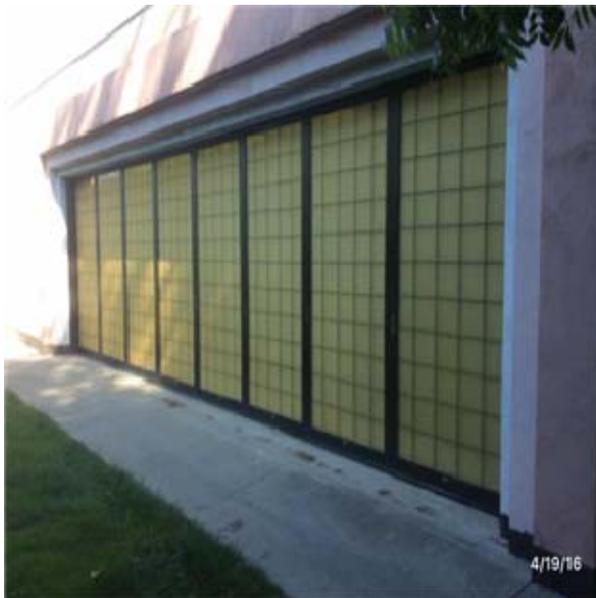
C1013 Retractable Partitions:- View of Operable Walls, ie hotel ballroom type

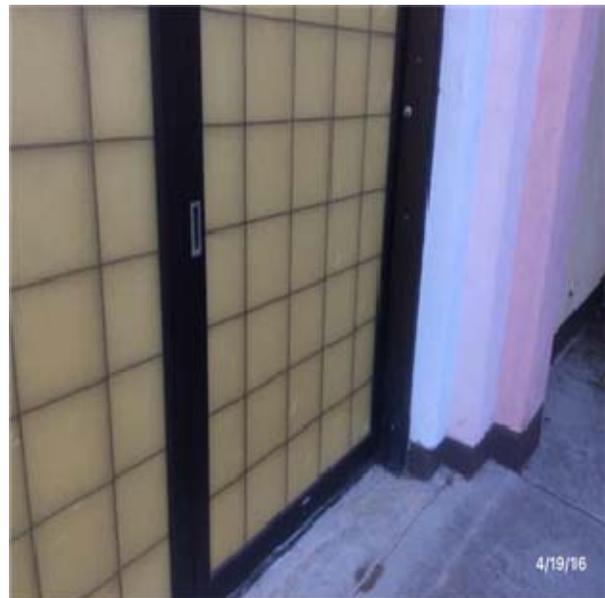
C1013 Retractable Partitions:- View of Operable Walls, ie hotel ballroom type

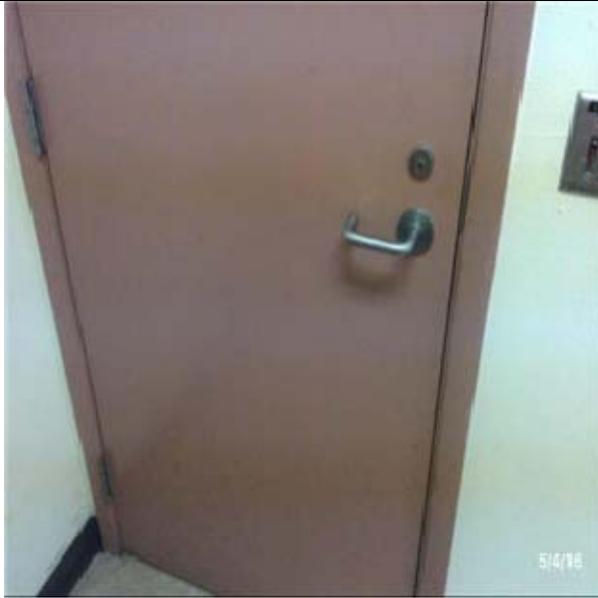
C1021 Interior Doors:- View of Interior Single Wood Door(s)

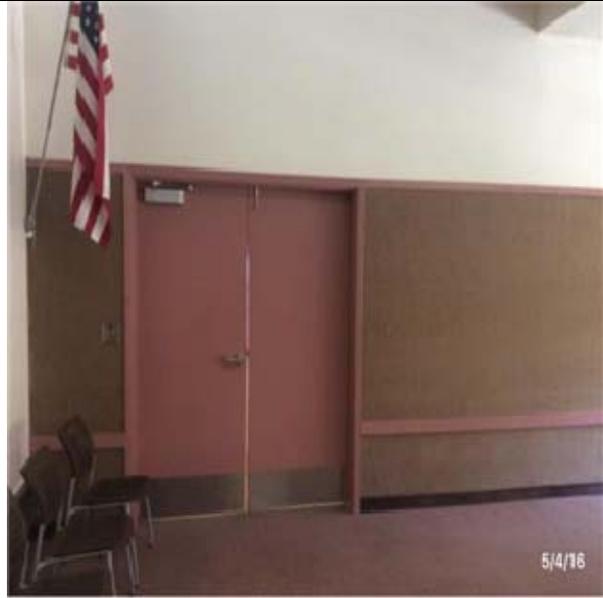
C1021 Interior Doors:- View of Interior Double Wood Door(s)

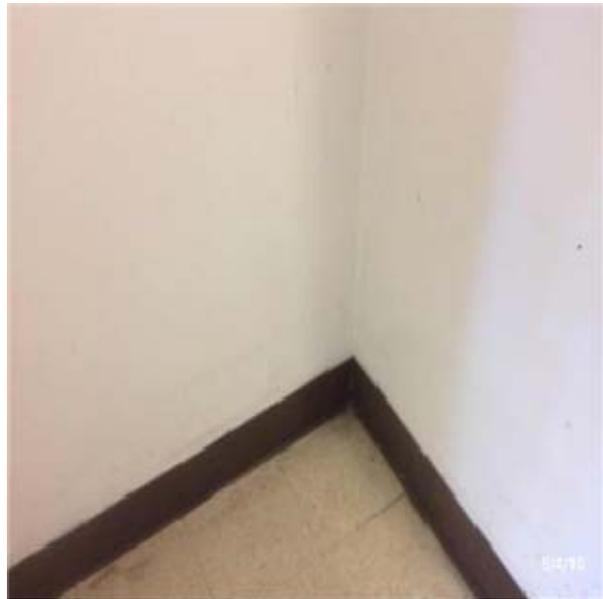
C3012 Wall Finishes to Interior Walls:- View of GRP panels

- + C Interiors: Replace Ceramic Wall Tiles at an estimated cost of \$13,167 in year 2021
- + C Interiors: Replace GRP panels at an estimated cost of \$16,678 in year 2021

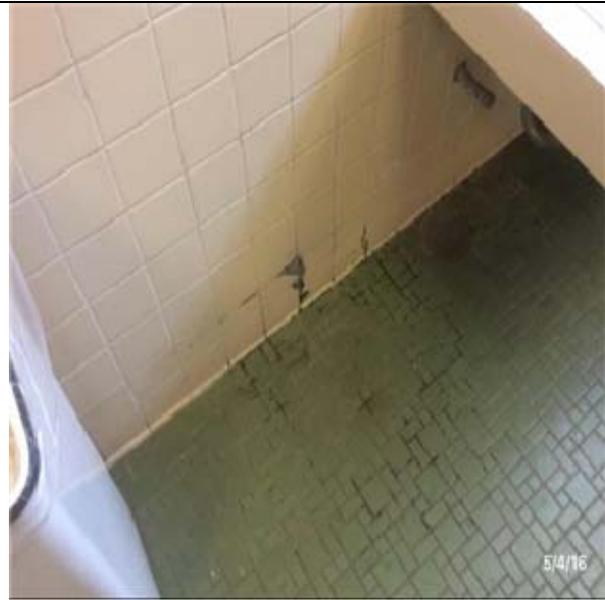
C3024 Flooring:- View of Ceramic Tile

- + C Interiors: Replace Painted Finish - Standard at an estimated cost of \$18,869 in year 2016
- + C Interiors: Replace Ceramic Tile at an estimated cost of \$6,855 in year 2021

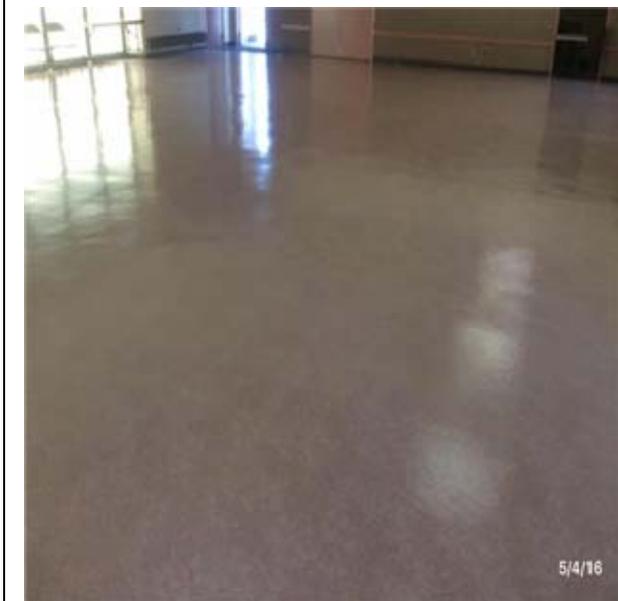
C3024 Flooring:- View of Vinyl Sheet

- + C Interiors: Replace Vinyl Sheet at an estimated cost of \$16,416 in year 2021
- + C Interiors: Replace Painted Finish - Standard at an estimated cost of \$18,869 in year 2024

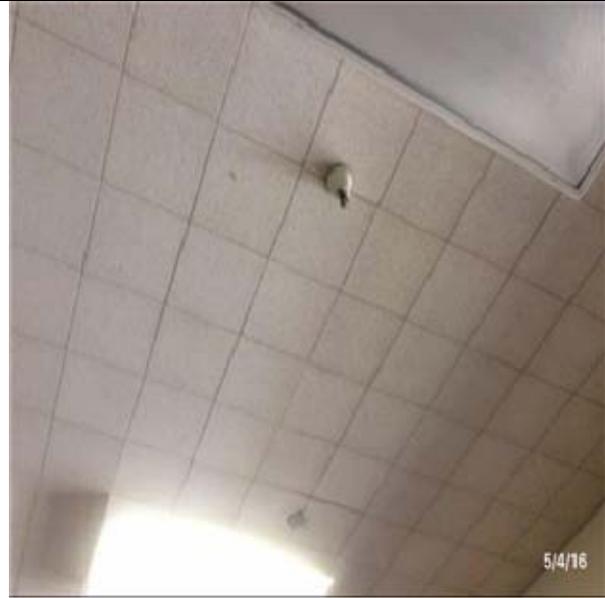
C3032 Suspended Ceilings:- View of Acoustic Ceiling System
- 4 x 2

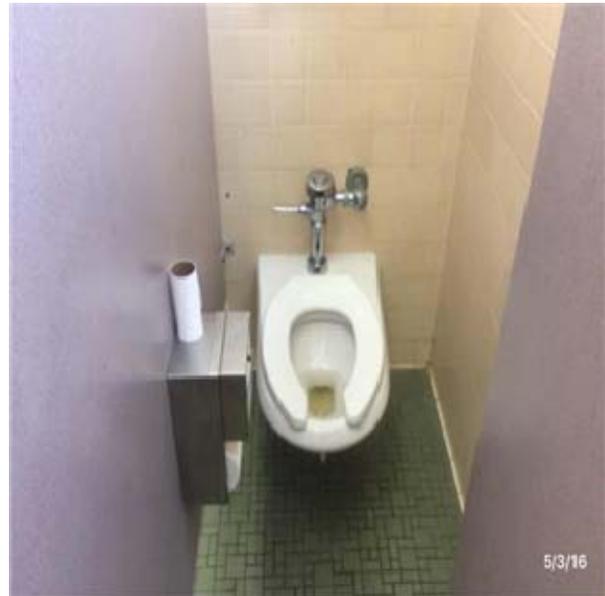
D2011 Water Closets:- View of Wall Mounted Water Closets

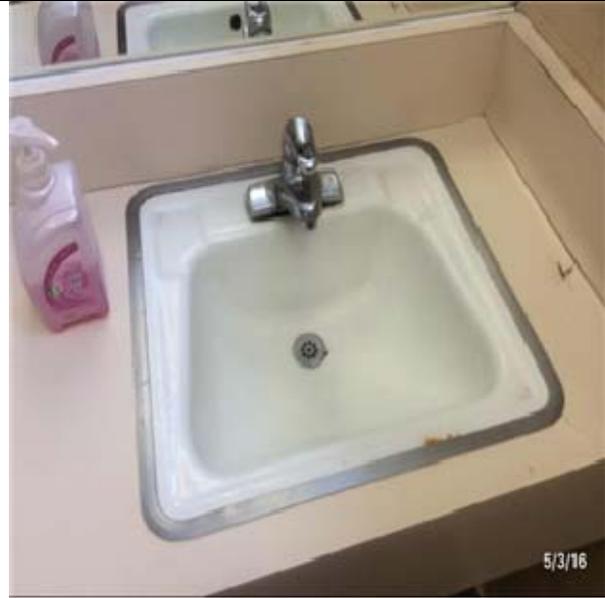
D2013 Lavatories:- View of Vanity Top Lavatories

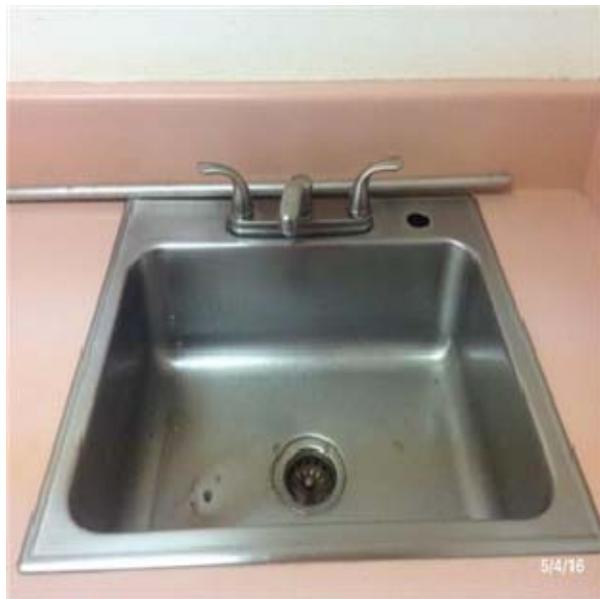
D2013 Lavatories:- View of Vanity Top Lavatories

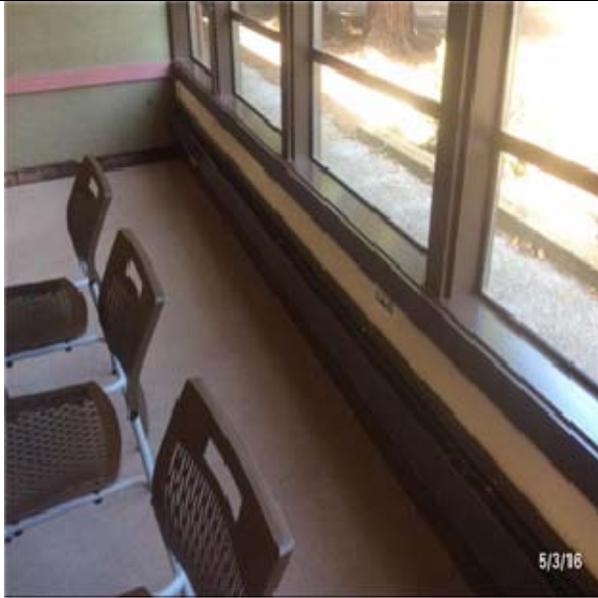
D3023 Auxiliary Equipment:- View of Baseboard Radiation Heaters - Hydronic

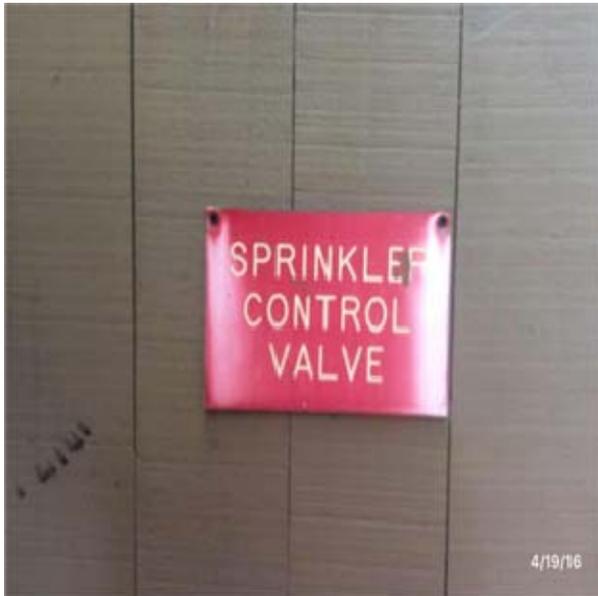
D4011 Sprinkler Water Supply:- View of Wet-Pipe Sprinkler System

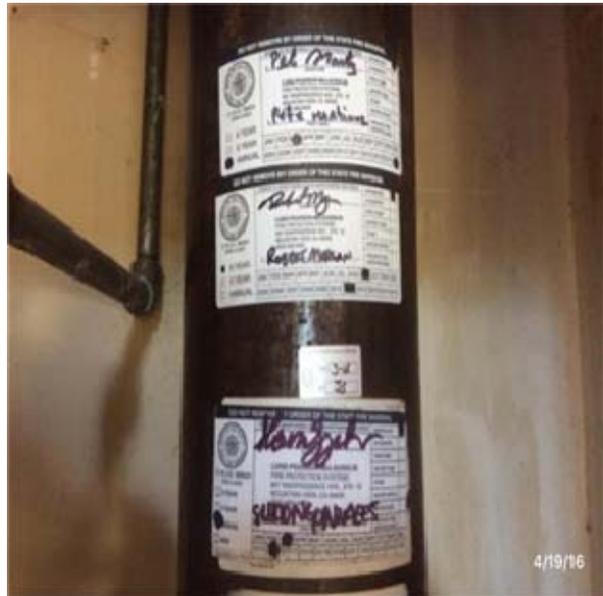
D4011 Sprinkler Water Supply:- View of Wet-Pipe Sprinkler System

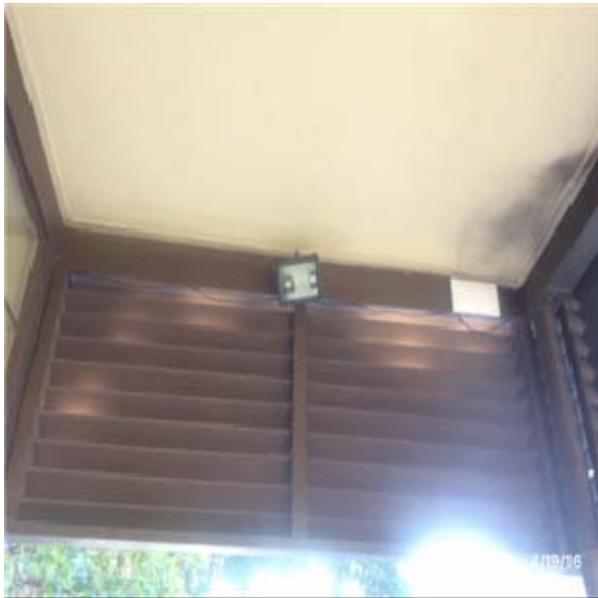
D5022 Lighting Equipment:- View of Interior Light Fixtures - Fluorescent

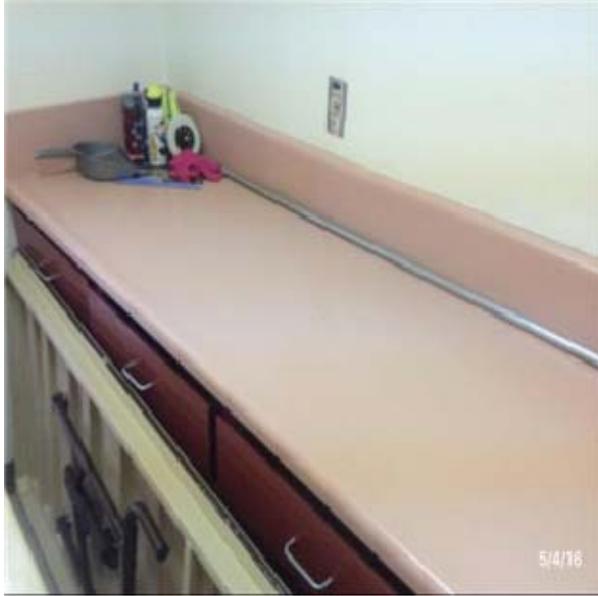
E1095 Unit Kitchens:- View of Unit Kitchens - Counter Top - Laminated
